# ELECTRIC & ELECTRONICS

Precision Radius Measurement for Improved Quality Control in Plastic Container Manufacturing

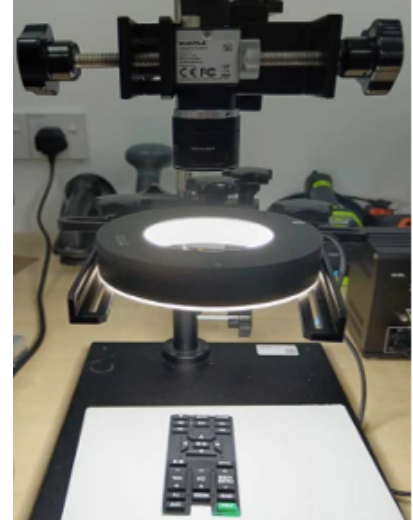
In keypad manufacturing, ensuring the correctness of printed labels and the presence of color-coded buttons is critical for both functionality and customer satisfaction. Manual inspection often leads to inconsistencies, human error, and slower production output. The absence or misplacement of color buttons and unclear printed labels can result in product rejections, warranty claims, and increased costs. These issues ultimately impact brand reliability and slow down production efficiency.

An automated vision inspection system was introduced to replace manual checking. Using a 5MP color camera, 16mm focal length lens, and ring light setup, the system accurately inspects keypad labels and detects the presence or absence of colored buttons. This solution ensures real-time OK / NG (pass/fail) detection, significantly reducing reliance on human operators. Unlike traditional manual inspection, this approach provides consistent results, faster processing, and minimizes the chances of defective units reaching customers.

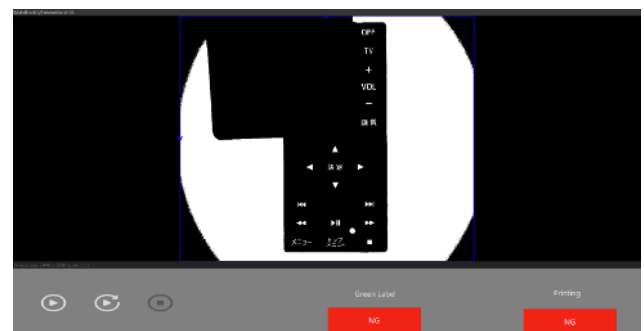
The implementation of the automated inspection system successfully identified printed label defects and missing buttons with high accuracy. Production lines experienced reduced inspection time while maintaining consistent quality output. The system minimized human error and allowed operators to focus on higher-value tasks, resulting in improved efficiency. Rejection rates were lowered, ensuring higher product reliability and cost savings in the overall process.
